Prevention of Turbine Rupture Disc Air Inleakage

By Lee Machemer, Jonas, Inc.

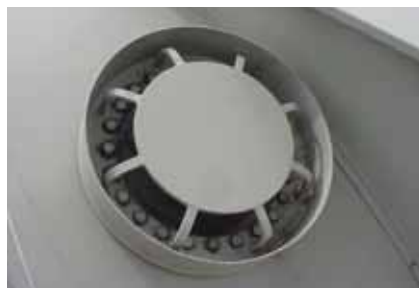
Figure 1- Typical Turbine Rupture Disc Housing

A common problem on low-pressure (LP) condensing steam turbines is air in-leakage through leaking turbine rupture discs. Turbines are equipped with rupture discs (Figure 1) to protect the turbine casings from deforming or rupturing due to an accidental increase of the internal steam pressure. They are an intentional weak spot meant to fail should the system get over-pressurized allowing it to vent out safely. During normal operation, the exhaust ends of LP turbines are under vacuum because they directly connect to condensers. Due to stress, corrosion, and other causes, the lead discs are susceptible to fatigue cracking and corrosion. Evaluation of several rupture discs by one nuclear plant found high cycle fatigue cracking at a location where the discs were being deformed by the rupture disc housing assembly. Cracks in

the discs were causing the assemblies to no longer being air-tight, which resulted in a major path for air leakage into the vacuum part of a steam system.

is leaking, this requirement often cannot be met. Subsequently, water and steam chemistry and cycle corrosion protection goes out of control and, in a case of severe air in-leakage, condenser vacuum and cycle output and efficiency are reduced. When severe, this problem can result in unit shutdowns to disassemble the rupture

These Covers are made from nylon reinforced rubber and neoprene and slide over the top of the rupture disc housing to form an air-tight seal. The Covers are custom designed to fit most rupture disc housing designs, installation takes approximately 20 minutes and does not require the unit to be shutdown. The material of the Rupture Disc Cover is highly resistant to the ambient environment for both indoor and outdoor turbine installations.

During operation of the turbine, if depressions appear on the top of the Cover, this is an indicator that the rupture disc is leaking. The rupture disc can either be replaced during the next outage, or the Cover can be left in place permanently. In addition to sealing the rupture disc to prevent air inleakage, the Covers protect the rupture disc from corrosive atmospheric contaminants.
